## Observed seismic behavior of three Chilean large dams

R. Verdugo

G. Peters

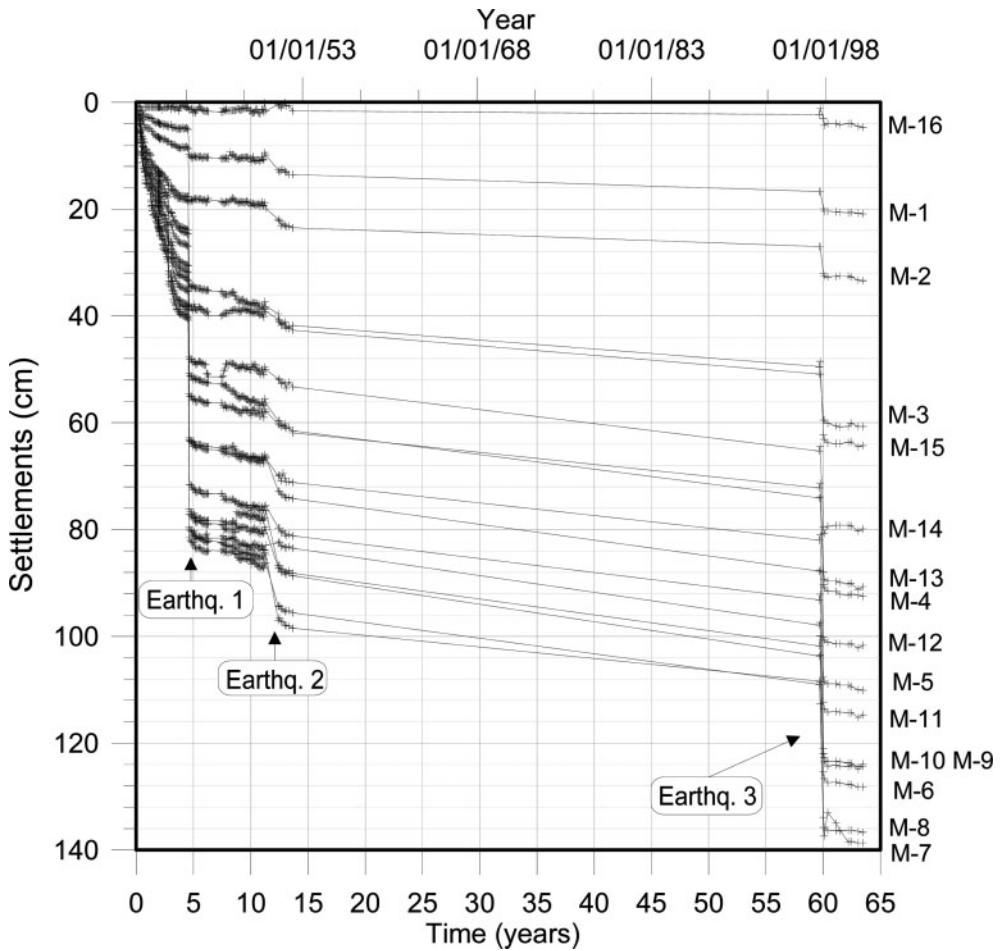
Figure 6. Chronological history of settlements.

The chronological history of measured settlements since 1938 at different control points at the crest of the embankment is presented in Fig. 6. The location of the control points are shown in Figs. 3 and 7. Additionally, the distribution of the settlements along the crest at different times is shown in Fig. 8.

- 1943 Earthquake  $\Delta_{SS} = 41.7$  cm, (Control point M-10)
- 1949 Earthquake  $\Delta_{SS} = 12.3$  cm, (Control point M-7)
- 1997 Earthquake  $\Delta_{SS} = 25.3$  cm, (Control point M-8)

At present, the total maximum seismically-induced settlement reaches a value close to 79 cm, which represents almost 1% of the dam high.

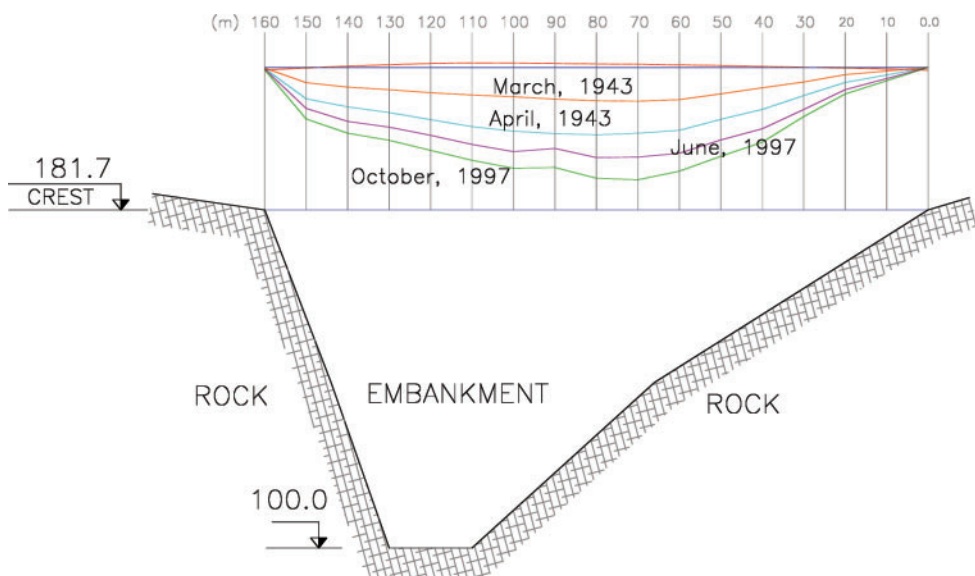
Figure 7. Control points and settlement distribution along the crest.

These data indicate that the maximum vertical settlement does not take place in the section associated with the maximum height of the rockfill. Unexpectedly, at least for the authors, the maximum vertical settlement occurs above the point where the bedrock undergoes a slope change. The maximum settlement corresponds to control point M7, whose chronological history is shown in Fig. 9.

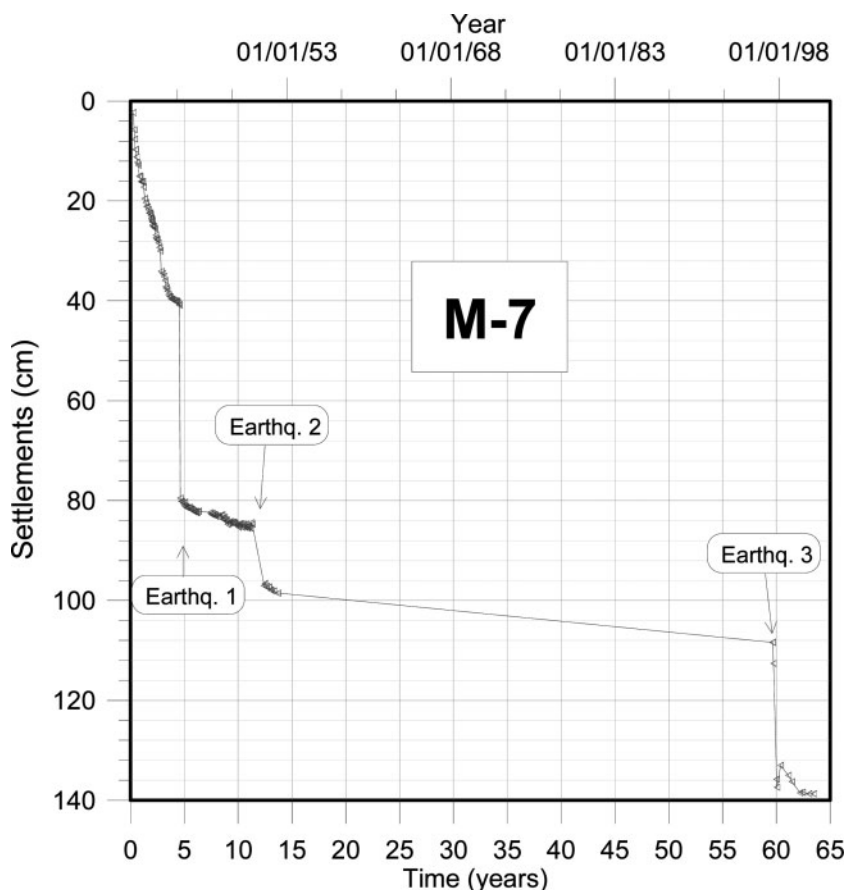
Figure 9. Chronological history of maximum settlement.

At the end of 2001, the total maximum settlement reached 138.7 cm, representing a settlement of 1.7% of the height of the dam after 63 years.

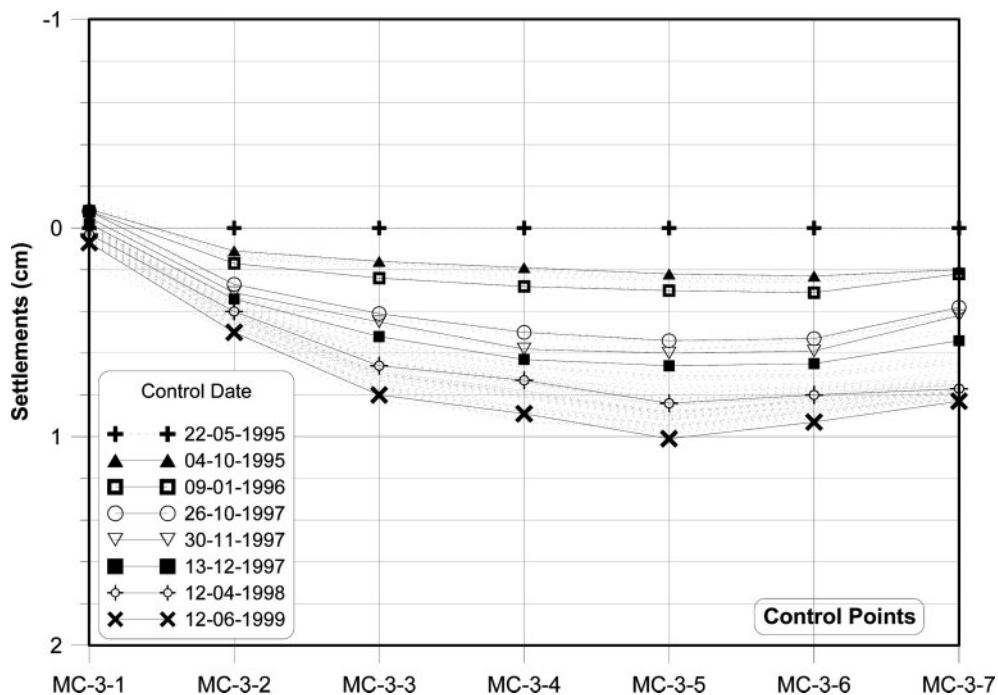
Figure 13. Vertical settlements along the crest.

Fig. 13 presents the measured settlements at different control points located along the dam crest. It is observed that the vertical deformation is in some way shifted to the right, confirming the results observed in Cogoti Dam that suggest that the shape of the bedrock has an important effect on the distribution of the vertical settlements, static and seismic.

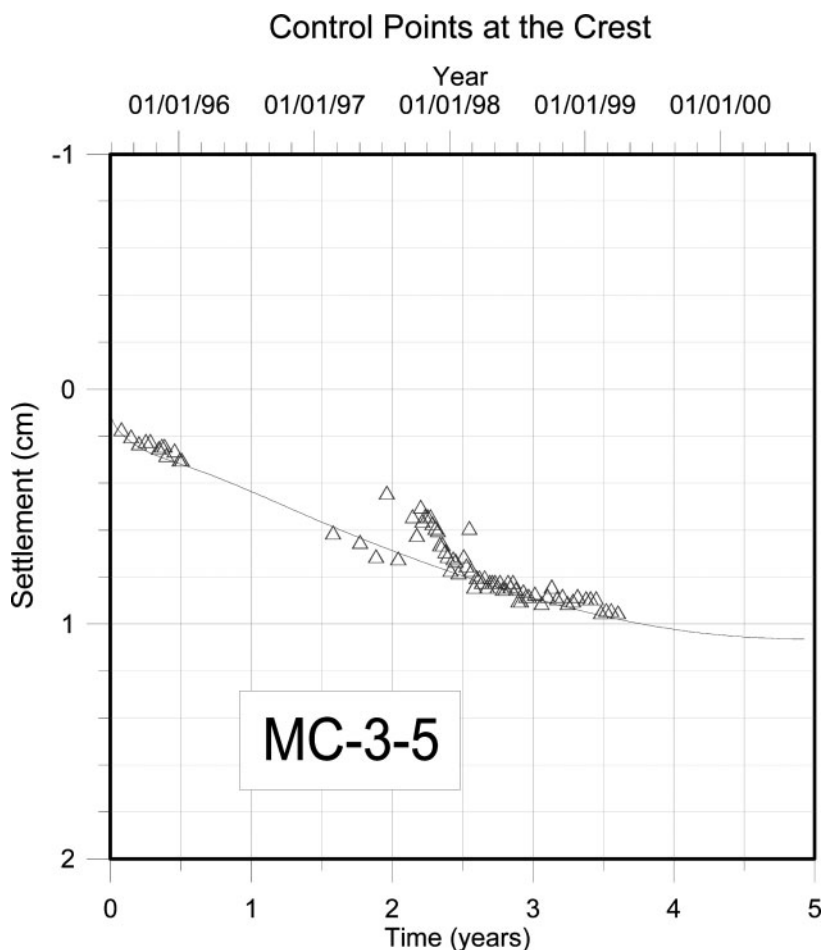
Figure 14. Chronological history of observed settlements at MC 3-5 control point.

The maximum settlement takes place at the control point MC-3-5, and the chronological history is shown in Fig. 14. It can be observed that the settlements after 4 years of operation are quite small

(1 cm) and it seems that the earthquake that hit the dam did not generate any particular change in the pattern of deformation.

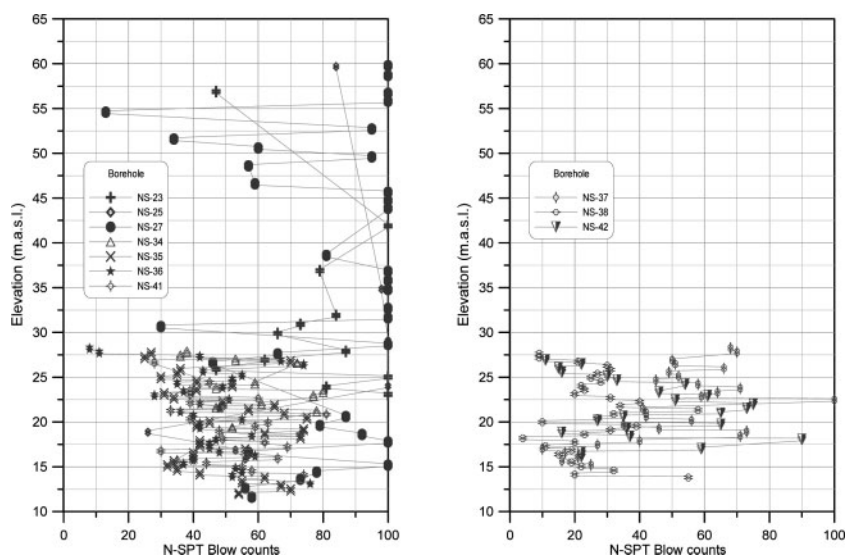
Figure 21. SPT N-values measured in the upstream zone.

The results are shown in Figs. 21 to 23 for the upstream zone, downstream zone and spillway zone, respectively. These results are not normalized to an overburden pressure of  $1 \text{ kg/cm}^2$ .

These data show significant number of boreholes where the SPT N-values presents values below 15–20 blow/30 cm, suggesting that liquefaction phenomenon could takes place under a strong motion as the one expected for the area.

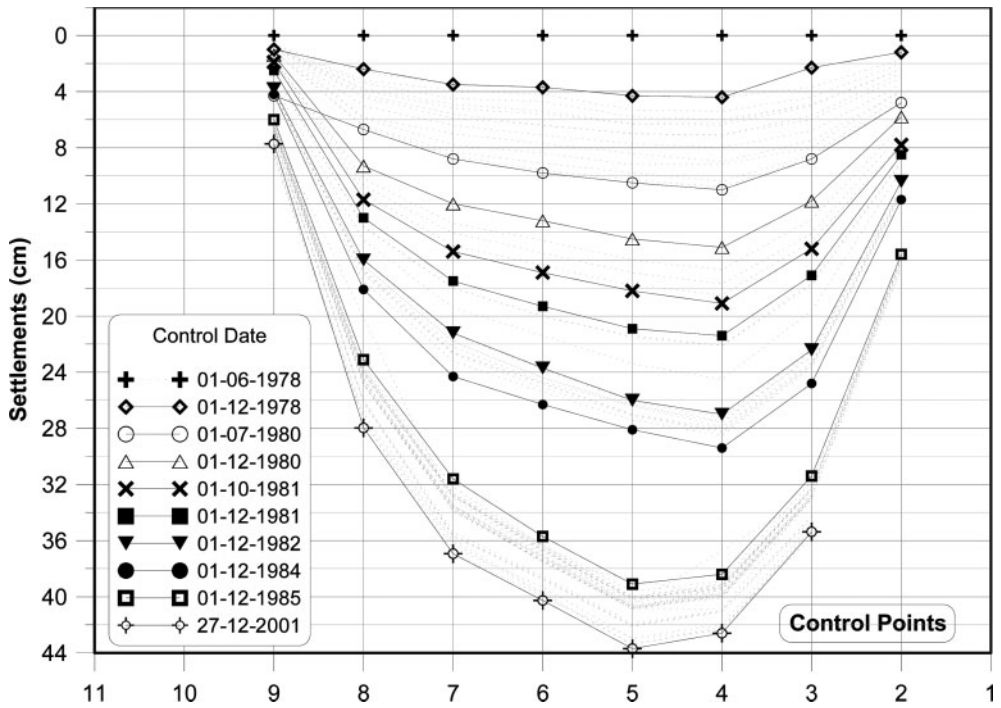
Figure 24. Settlements recorded in the crest of Aromos Dam.

The settlements recorded at the crest of dam are shown in Fig. 24. It can be observed that a regular development of the settlements before and after the 1985 earthquake occurred. Again, it is observed that the maximum vertical deformation takes place above an irregularity in the bedrock.

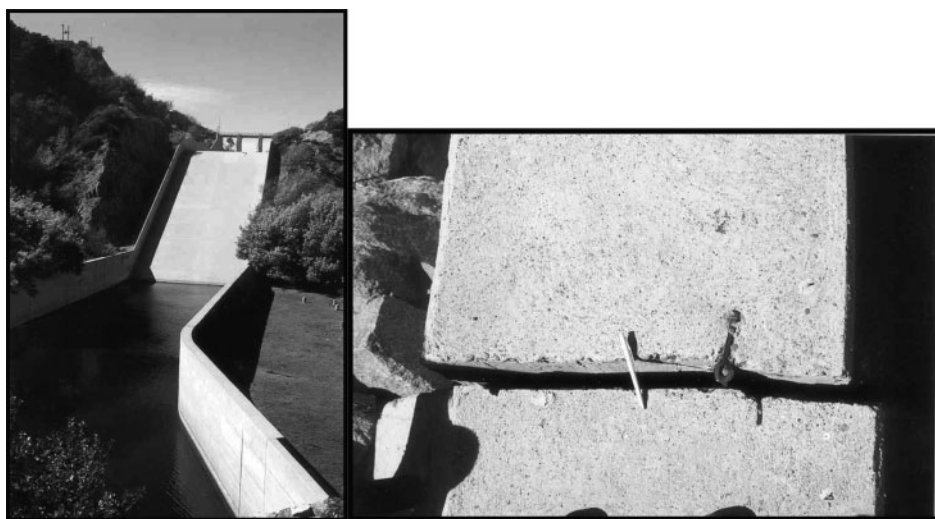
Figure 27. Relative displacements in the spillway walls.

Additionally, it is important to mention that the drainage columns located at the toe of the dam worked and water was observed coming up from these wells. Moreover, the intensity of the ground motion in the area of Aromos Dam is somewhat reflected in the relative displacements observed in the concrete walls of the spillway after this earthquake, as shown in Fig. 27.

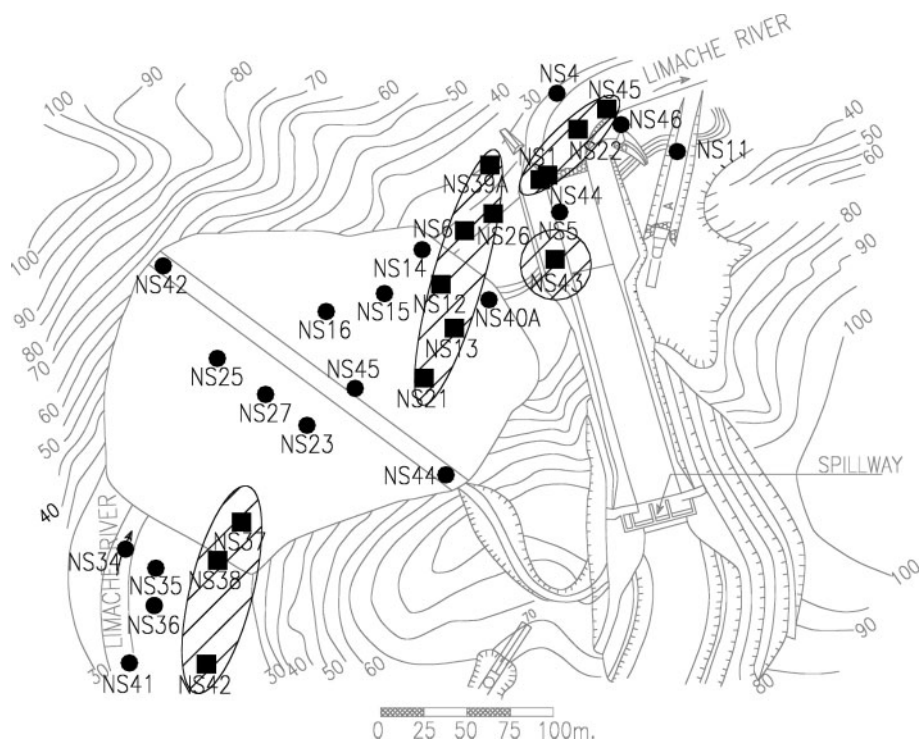
Figure 28. Identification of boreholes with SPT N-values lower than 15–20 blow/30 cm.

It can be observed that the areas of low SPT N-values are surrounded by areas with high SPT N-Values. This particular geotechnical condition can be the explanation of the good behavior of this site. The areas with high SPT N-values should have two important contributions:

- They dilate reducing the pore pressure build-up in the loose zones
- Because they are stiffer, they take more of the dynamic load, reducing the disturbances of loose zones.
