# Seismic Performance of Earth Structures during the February 2010 Maule, Chile, Earthquake: Dams, Levees, Tailings Dams, and Retaining Walls

The 27 February 2010 Maule, Chile, earthquake occurred during the driest time of the year, which implied that most of the soils in the slopes were not saturated and that the dams had extra freeboard. This may explain the small number of slope failures caused by the earthquake. However, two important earth dams suffered seismically induced permanent ground movements, but no catastrophic damage was reported because the reservoirs levels were low. Five medium-sized mine tailings dams failed due to liquefaction; one of them tragically caused four casualties. Retaining structures of all types performed well and no failures were observed. [DOI: 10.1193/1.4000043]

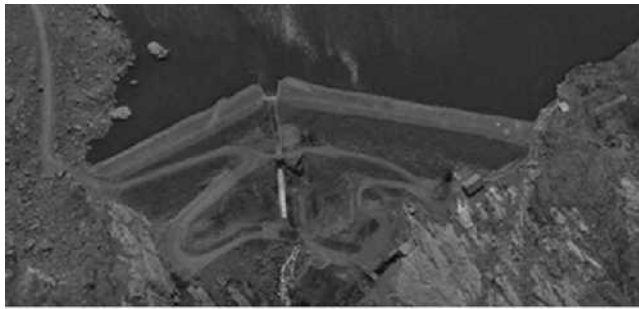
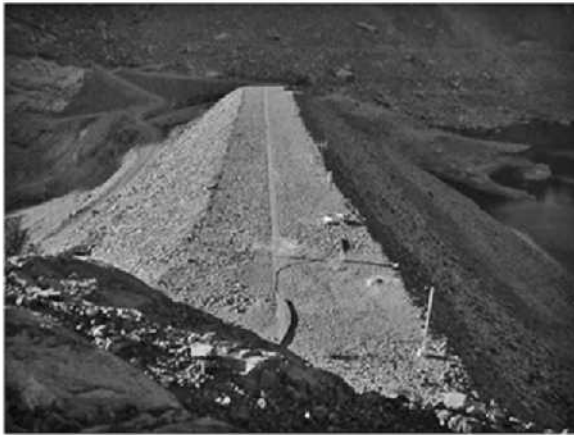
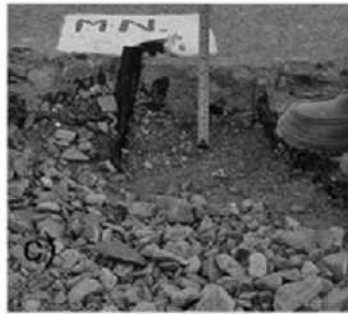
- The dam with the asphaltic core is Los Cristales Dam, which was built in 1976 with the spillway in a rock outcrop located close to the center, dividing the dam in two sectors (Figure 5a). It has a total crest length of 310 m and a maximum height of 27 m. The upstream and downstream slopes are 1.9H:1V and 1.75H:1V, respectively (Figure 5b). The asphaltic vertical concrete core has a constant thickness of 60 cm. The post seismic survey carried out on the dam indicated settlements of the shells of only a few millimeters. Even though the seismic response of this dam was satisfactory, the core settled about 14 cm close to one of the abutments, as shown in Figure 5c.

**Figure 5.** (a) Plant view of Los Cristales Dam (Google Earth). (b) Photograph taken from left abutment; (c) settlement of the asphaltic concrete core.

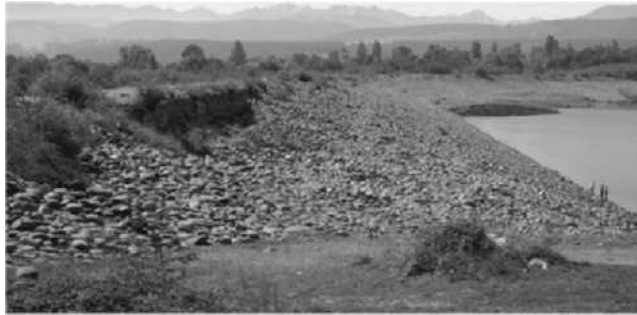
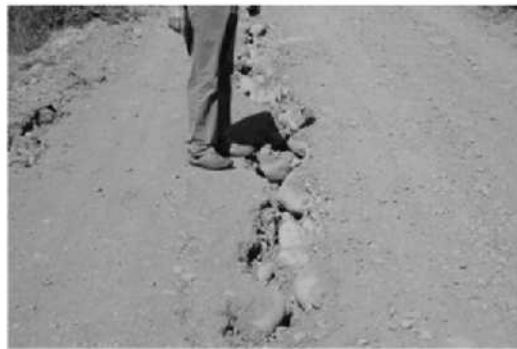
was built in 1970, is located approximately 28 km east of Chillán. It is a zoned earthfill dam that has a crest length of 1,040 m long and a maximum height of 31 m. Figure 6 shows the design section of the dam. Following the earthquake, a portion of the upstream slope experienced a failure that generated significant deformations and cracks as shown in Figures 7a and 7b. Maximum vertical displacements of the upstream slope were observed towards the left abutment, reaching values close to 4 m.

**Figure 7.** (a) Failure of upstream slope of Coihueco Dam. (b) Longitudinal crack along crest.

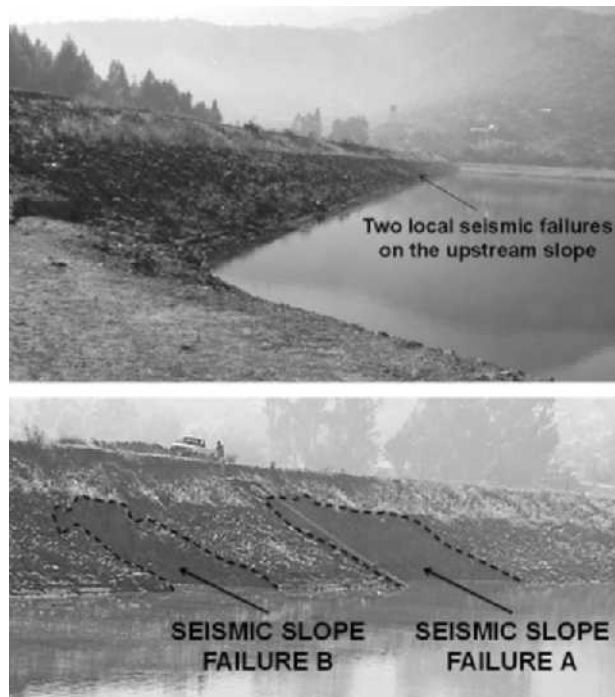
In the case of Lliu-Lliu Dam the available information is also quite limited. Two localized seismic slope failures took place in the upstream slope as shown Figures 15. The length along

**Figure 15.** Seismic slope failures occurred in Lliu-Lliu Dam.

the crest of these failures was 36 m and 21 m, respectively. Additionally, a series of longitudinal cracks along the crest with a maximum lateral openings of 10 cm were observed (Figure 16). Lliu-Lliu Dam was constructed around 1920 and has a crest length of about 500 m and a maximum height of 18 m. The upstream and downstream slopes had similar inclinations of about 1.5:1.0 ( $H:V$ ), and a crest width of 8 m. The available information indicated that both shells consisted of gravelly material with an important fines content of clayey soils. The core would have been constructed with a mixture of fines soils and bentonite. All the aftershocks, including one of Magnitude 6.9 (11 March 2010), with an epicenter located approximately 160 km south of the dam, did not induce any additional movements of the upstream slope.

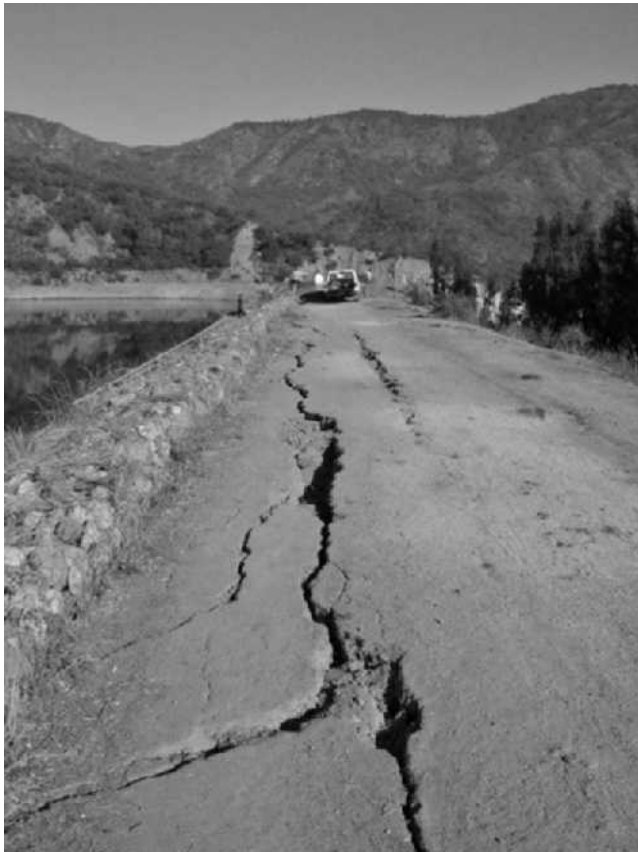
**Figure 16.** Open cracks observed along the crest of Lliu-Lliu Dam.

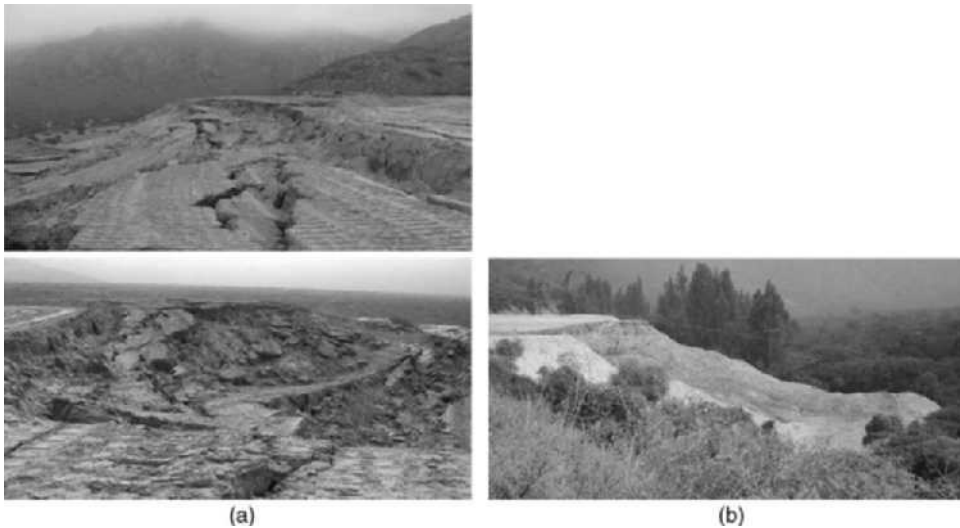
Bellavista Dike No.1 collapsed and a significant volume of tailings flowed into Dike No. 2, which acted as a buffer, stopping the flow of the tailings (Figure 19a). Dike No. 5 of Veta del Agua experienced a rather limited seismic failure, with the toe of

Figure 19. (a) Flow failure of Bellavista Dike No. 1 (Ramirez 2010). (b) Flow failure of Veta del Agua Dike No. 5 (courtesy of Prof. R. Espinace).

the dike flowing for a distance of 100 m, reaching El Sauce Creek. Figure 19b shows Dike No. 5 after the earthquake. Las Palmas tailings dam experienced the most catastrophic seismic failure triggered by the 2010 Chilean earthquake. The mine was operating from the early 1980s until 1997, when the mining activity finished and the tailings pond was partially covered with a 15 cm layer of gravelly material. The tailings deposit consisted of two dams (a lower one and an upper one). Both dams were constructed in stages using the upstream construction method.

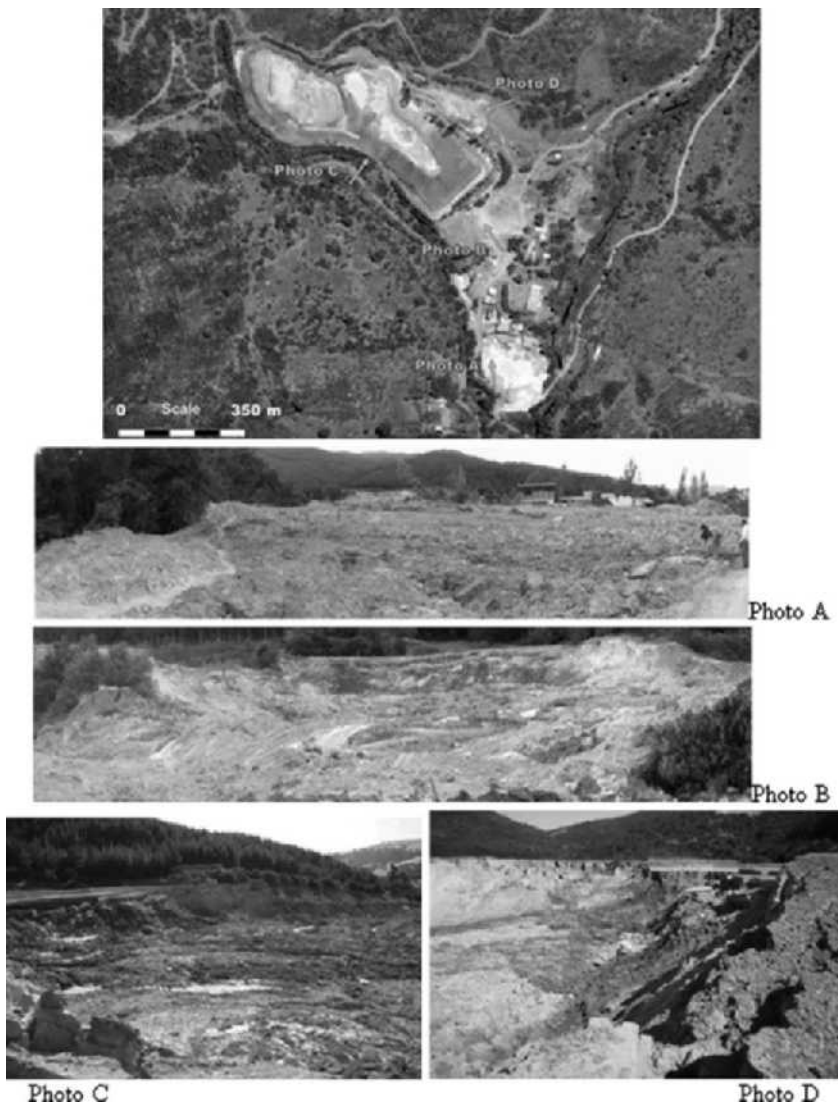
During the Maule earthquake, the tailings deposit retained by the lower dam of Las Palmas liquefied, the eastern portion of the tailings impoundment nearest the mine facilities was breached, and a tailings volume in excess of 100,000 m<sup>3</sup> flowed a distance of about 0.5 km, killing four people in a house that was buried under four meters of tailings (Figure 20). The tailings liquefied again (less severely) during the aftershocks of Magnitude greater than 5. During these aftershocks, new evidence of sand boils and ejecta as well as water draining from the subsurface was observed. A number of these liquefaction features were observed in the terraces associated with the upstream construction method at the western end of the tailings

**Figure 20.** Las Palmas flow failure.

impoundment area even though no full breach of the structure occurred at that location. Field surface wave measurements conducted in the unfailed tailings material indicated shear wave velocity of the order of 250 m/s, and dynamic cone penetrometer soundings performed in both unfailed and failed tailings materials yielded blow counts of about 10 (Bray and Frost 2010).

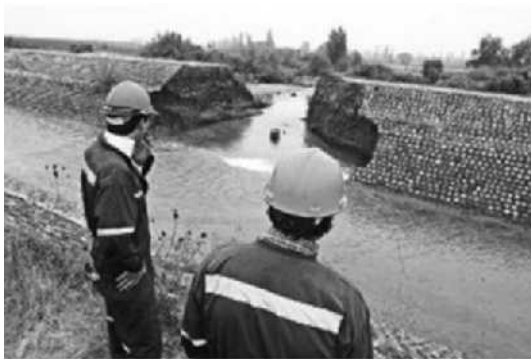
A 15 m-wide breach of an engineered earthen levee (Figure 21) occurred west of Colbún (S35.698672°, W71.487294°) at 6:50 pm on 13 March 2010, two days after the  $M_w = 6.9$  aftershock (epicenter at S34.259°, W71.929°) that occurred on 11 March 2010 at 11:40 a.m. The levee was inspected soon after the  $M_w = 8.8$  main shock of 27 February 2010 and after the 13 March 2010 aftershock, and no evidence of distress was noted. The breach produced a localized discharge of water 80 cm high that flooded a few homes. The levee fill material is poorly graded sandy gravel with a significant amount of cobbles that has about 10% low plasticity fines (i.e., GP-GC with cobbles). The levee is approximately 7 m high with a crest width of 6 m, and 1.5H:1V side slopes with a cobble facing on the water side. The levee was reported to have been built 25 years ago. Whereas at other locations along the levee, existing material was excavated to build the levee, it is reported that little or no excavation was required at this location because the original ground surface elevation was already low. The actual cause of the levee breach is not clear.

**Figure 21.** Earthen levee breach west of Colbún (S35.698672°, W71.487294°; photograph taken by Mr. Juan Carlos Romo of *El Mercurio* on 12 March 2010; <http://diario.elmercurio.cl>).

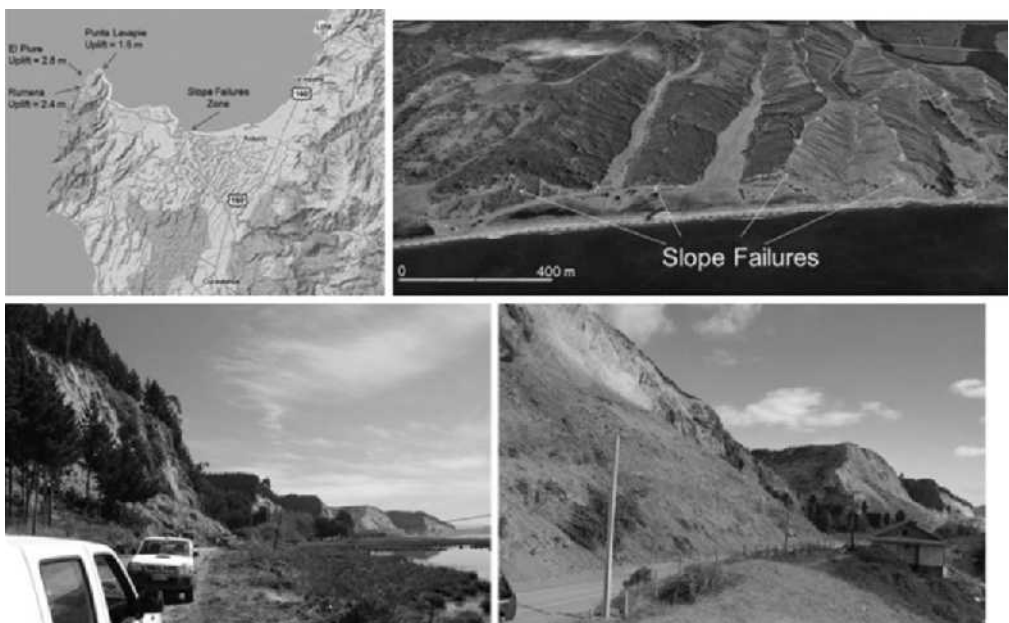
**Figure 22.** Massive slope failure occurred in Arauco area.

in other areas where no failures were observed. The particular condition that affected the area of Arauco, where these massive seismic slope failures occurred, is the significant tectonic uplift that reached nearly 3 m near the coast. It is hypothesized that the superposition of the inertial forces of the earthquake plus the distortion generated by the crustal deformation could be responsible for the observed slope failures. It is interesting to remark that many steep slopes in other areas such as those shown in Figure 23 did not fail, and only limited surficial displacements were observed.

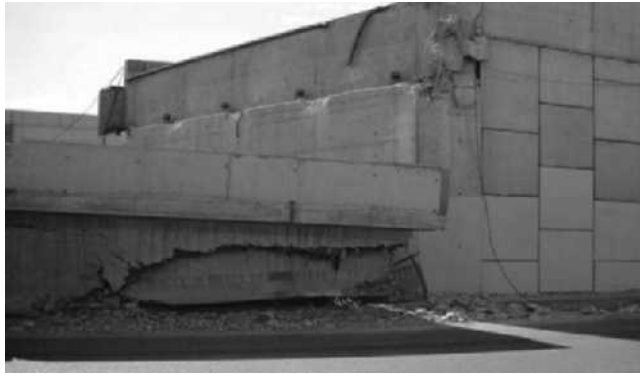
**Figure 24.** Intersection of Américo Vespucio Norte and Independencia, Santiago. The Reinforced Earth™ abutment performed well despite bridge collapse.

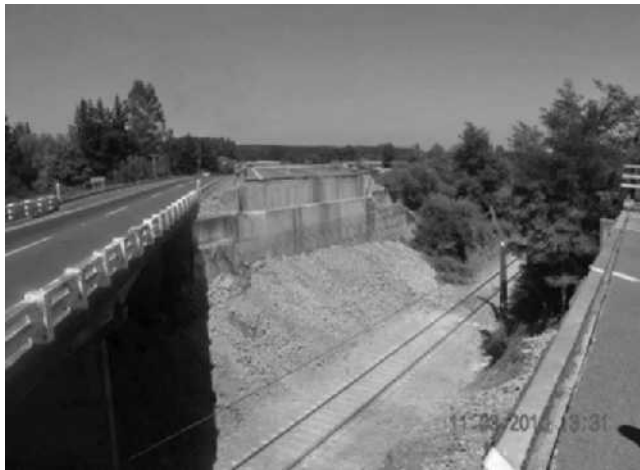
**Figure 25.** Reinforced Earth™ bridge abutments at a collapsed rail crossing on Route 5, north of Parral.

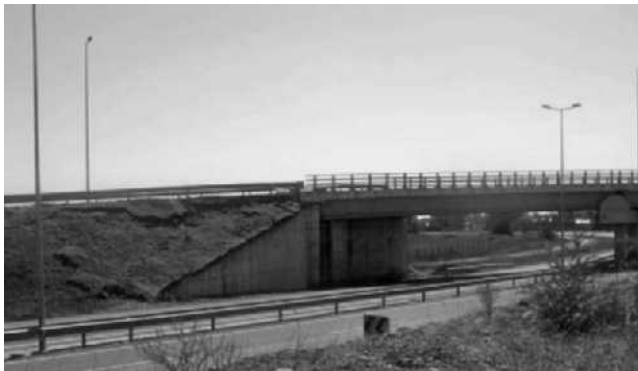
**Figure 27.** Surficial sloughing on a Route 5 overpass bridge approach embankment north of Chillán, with the abutment showing no evidence of damage.

shaking with concrete seats that were spalled or completely fractured, while the concrete abutment retaining walls performed very well and showed no evidence of damage. Figure 27 shows one such bridge approach embankment and abutment wall on Route 5 north of Chillán. Here, the approach embankment at one end suffered a surficial slump and the bridge deck had temporary scaffolding supporting it at the other abutment as it was close to sliding off its seat. In contrast, the abutment walls showed no evidence of distress.

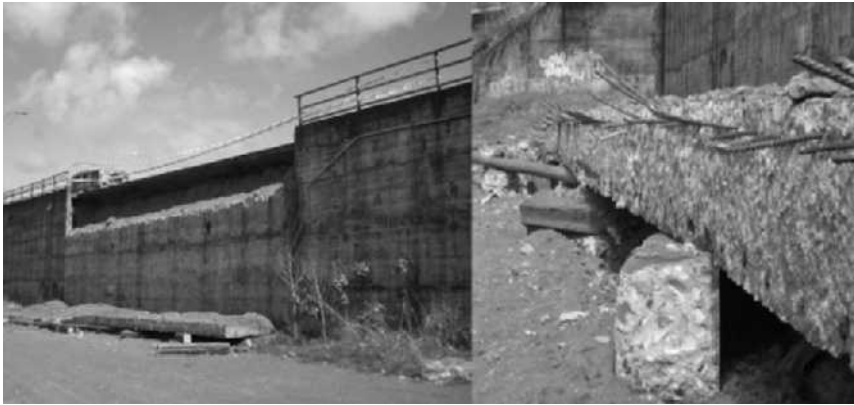
A rare failure of the uppermost section of a reinforced concrete retaining structure was observed in San Pedro, about 110 km south of the epicenter. The wall (Figure 28) was located within 3 km of the south approach to the Llacolen Bridge the Bio-Bio River connecting Concepción and San Pedro. The 16-inch thick wall was reinforced vertically with No. 3 or No. 4 bars on 12-inch centers. Failure occurred at the uppermost “cold joint,” where

**Figure 28.** Failed reinforced concrete retaining structure in San Pedro. Failure occurred along a concrete “cold joint” and showed complete corrosion of the reinforcements (right photo).

the top wall section toppled to the east apparently due to inertial forces. The reinforcement at this cold joint was badly corroded (Figure 28) and likely was the primary cause of the failure. The granular backfill is still clearly self-supporting.
