## Observed seismic behavior of three Chilean large dams

R. Verdugo

G. Peters

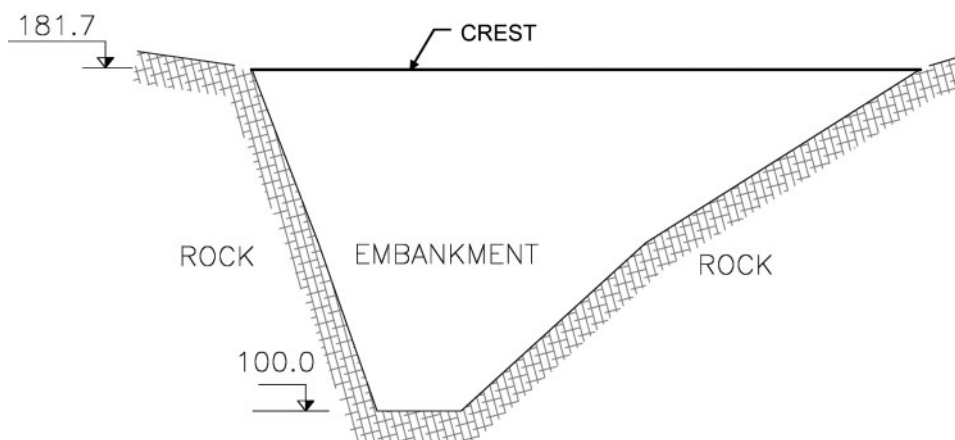
Figure 4. Gorge profile.

The cross-section of the gorge is shown in Fig.4, where it can be seen that the profile is a rather unsymmetric, with the right abutment less steep and with a change in its inclination. It will be shown later that a concentration of the crest settlements occurred above this point of slope change. The face slab is made of a series of square concrete plates of  $10\text{ m} \times 10\text{ m}$ , which have a thickness varying from 80 cm at the base to 20 cm at the top, where it continues as a short vertical retaining wall of 1 m high. The concrete face is resting on a layer with an average thickness of 3 m and consisting of hand-placed small rock particles. Just beneath the vertical and horizontal joints a continuous ditch was constructed to provide a better support to the joints. This ditch system is approximately 0.7 m deep and 1.2 m wide. The joints between concrete plates were sealed by means of copper waterstops of 1.5 mm thickness and 60 cm wide. Additionally, the openings between plates were filled with asphalt. The distribution of the individual concrete plates is shown in Fig. 3.

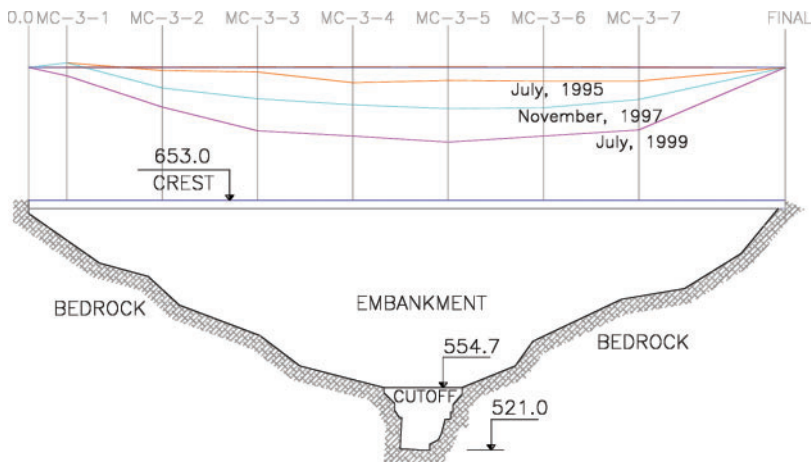
Figure 11. Profile of the valley and settlement distribution.

The shape of the throat of the rather narrow valley eroded by Huasco River is shown in Fig. 11. The profile is rather regular and it is possible to assume that the profile totally consist of bedrock. A cutoff wall made of plastic concrete was built in the fluvial material located at the river bed.

Fig. 13 presents the measured settlements at different control points located along the dam crest. It is observed that the vertical deformation is in some way shifted to the right, confirming the results observed in Cogoti Dam that suggest that the shape of the bedrock has an important effect on the distribution of the vertical settlements, static and seismic.

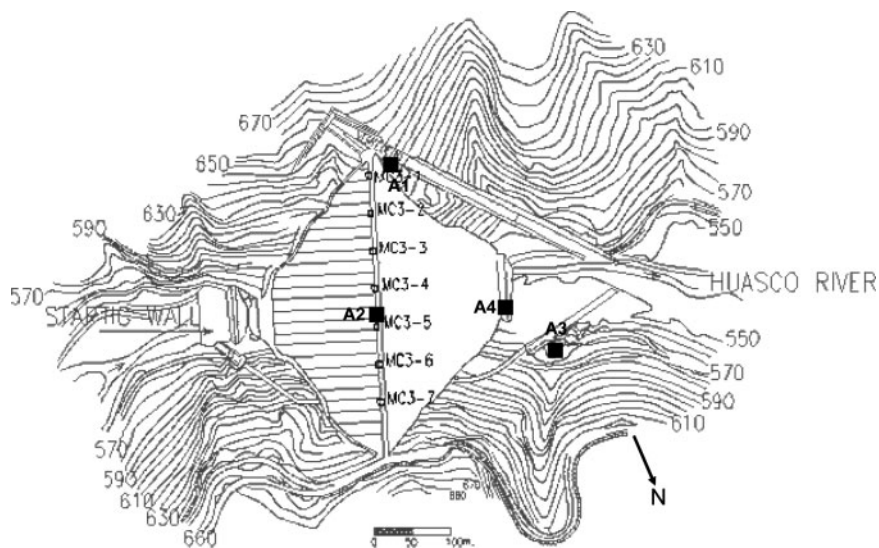
Figure 12. Accelerometers and control points of settlement.

Control points along the crest of the dam were installed to monitor the settlements, which are indicated in Fig. 12. Accelerometers were installed at different locations in order to study the seismic response of the dam, and the locations are indicated in Fig. 12. The accelerometer A3 is installed in rock.

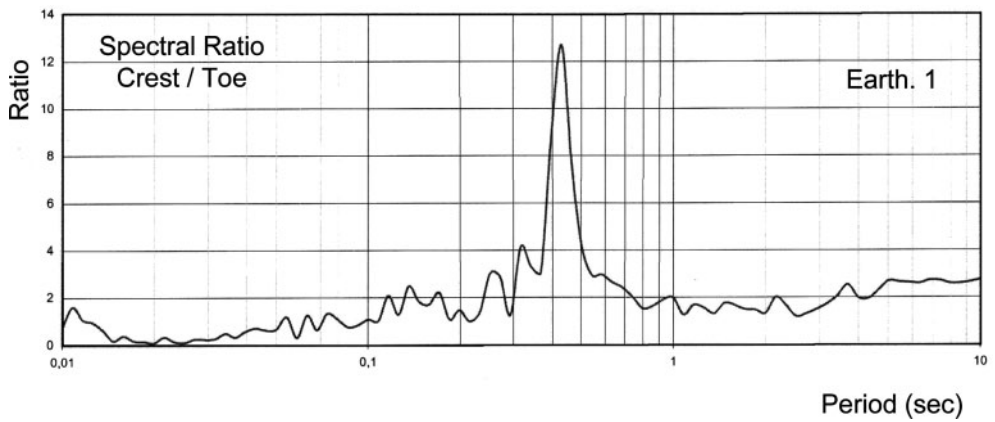
Figure 15. Typical result of spectral ratio Crest – Toe.

The values of the peaks are almost identical in most cases and the numerical smoothing that is always necessary to apply to the Fourier Transform is avoided. Additionally, the ratio of response spectra are less sensitive to noise and the peaks are easier to identify. Typical results are shown in Fig. 15.

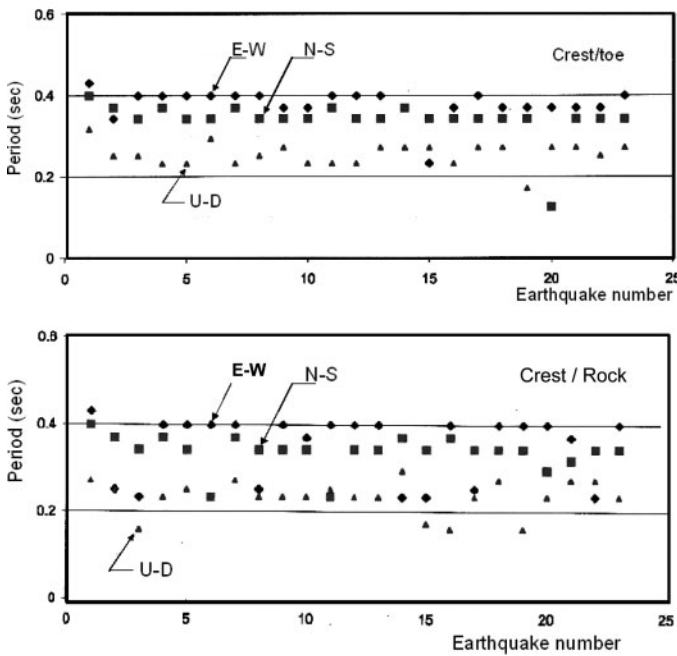
Figure 16. Predominant period computed in each earthquake.

The periods associated with the maximum value of the response spectral ratio were identified and considered as predominant periods. The analysis of the available data is summarized in Fig. 16. It can be seen that a systematic predominant period for different earthquakes and different ratios (“crest – rock” and “crest – toe”) is obtained. According to these results, the predominant period of Santa Juana Dam in the E-W direction would be:  $T = 0.4$  seconds.

Where,  $H$  and  $V_s$  represent, respectively, the height of the dam (113.4 m) and the shear wave velocity of the fill ( $\approx 700$  m/sec). The theoretical predominant period would be:  $T = 0.42$  seconds.

The match between empirical and theoretical values is quite good, although the geometry of Santa Juana Dam (crest length/high:  $390/113.4 = 3.4$ ) does not satisfy the condition of plane deformation (crest length/high  $> 4$ ).

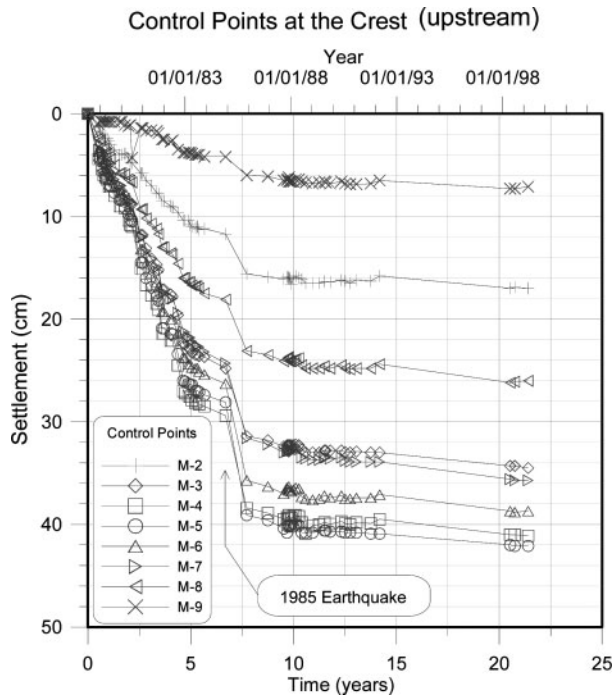
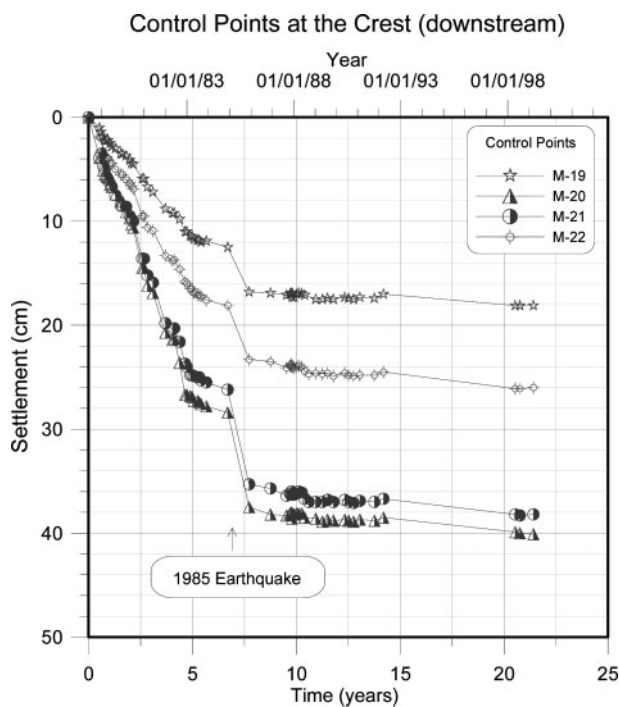
The chronological history of measured settlements in different control points at the crest of the embankment is presented in Figs. 25 and 26 for the upstream and downstream side, respectively.

Figure 25. Chronological history of settlements at the upstream side of the crest.

Figure 26. Chronological history of settlements at the downstream side of the crest.
