# Seismic Performance of Earth Structures during the February 2010 Maule, Chile, Earthquake: Dams, Levees, Tailings Dams, and Retaining Walls

The 27 February 2010 Maule, Chile, earthquake occurred during the driest time of the year, which implied that most of the soils in the slopes were not saturated and that the dams had extra freeboard. This may explain the small number of slope failures caused by the earthquake. However, two important earth dams suffered seismically induced permanent ground movements, but no catastrophic damage was reported because the reservoirs levels were low. Five medium-sized mine tailings dams failed due to liquefaction; one of them tragically caused four casualties. Retaining structures of all types performed well and no failures were observed. [DOI: 10.1193/1.4000043]

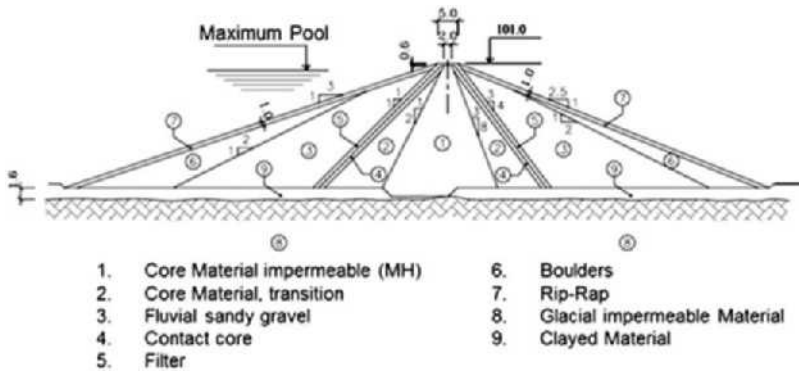
**Figure 6.** Design cross section of Coihueco Dam (all units in meters).

was built in 1970, is located approximately 28 km east of Chillán. It is a zoned earthfill dam that has a crest length of 1,040 m long and a maximum height of 31 m. Figure 6 shows the design section of the dam. Following the earthquake, a portion of the upstream slope experienced a failure that generated significant deformations and cracks as shown in Figures 7a and 7b. Maximum vertical displacements of the upstream slope were observed towards the left abutment, reaching values close to 4 m.

It is important to note that based on the experience of the first author with Chilean dams built before the 1960s, project designs were commonly for zoned dams, but the actual as built conditions were closer to homogeneous dams. This seems to be the case of Coihueco Dam also.

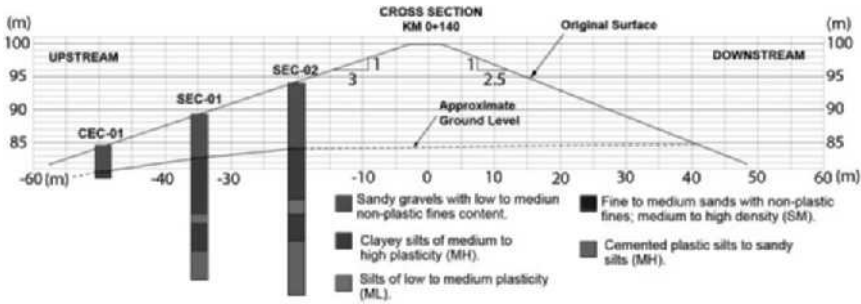
Figure 8. Soil identified in the exploration of Coihueco Dam.

To assist in investigating the cause of the observed failure, a limited geotechnical exploration was performed, consisting of two boreholes, SEC-01 and SEC-02, of 25 m and 32 m depth, respectively, and one test pit of 5 m depth (CEC-01). The location of the borehole and test pit logs are illustrated in Figure 8 relative to the dam cross section, and the stratigraphic profile with measured standard penetration test (SPT) blow counts (N-values) and fines contents (F.C., percent passing #200 sieve) are shown in Figure 9. The Atterberg Limits

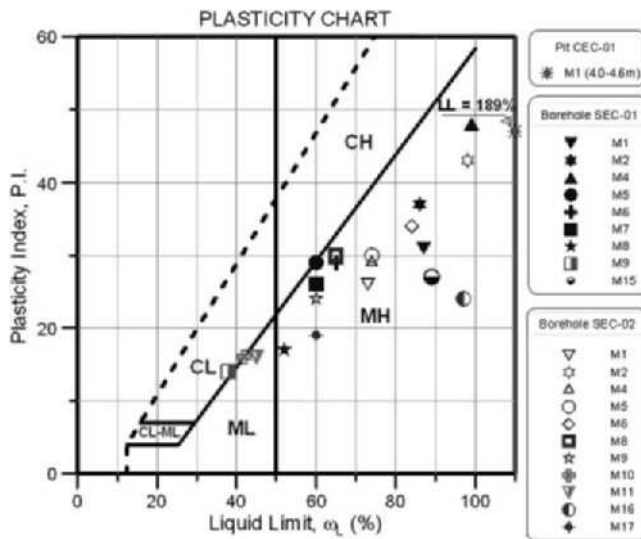
Figure 10. Plasticity of samples retrieved from Coihueco Dam.

are plotted in Figure 10. The MH soil likely contains allophane, which is commonly present in southern regions of Chile. The foundation materials encountered in the exploration consist of the following:

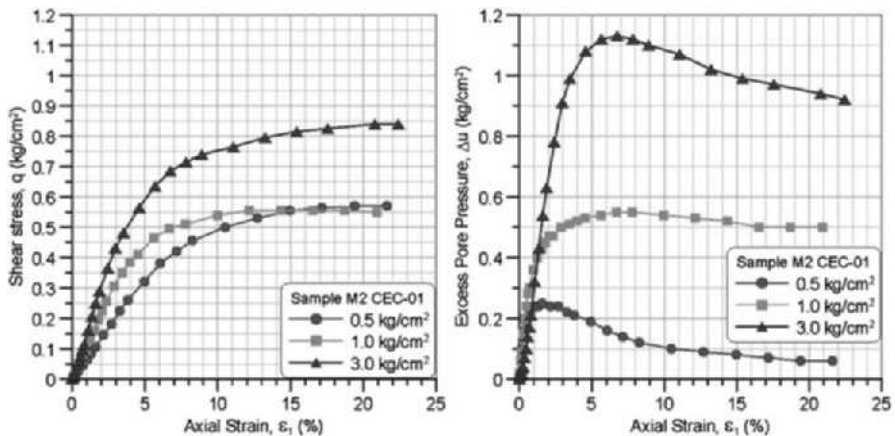
Figure 11. Triaxial test results, sample M2 CEC01. Coihueco Dam.

Isotropically consolidated, undrained triaxial tests with porewater pressure measurements (CIU) were performed on “undisturbed” samples retrieved with Shelby tubes. The stress-strain and pore water pressure responses for two samples are presented in Figures 11 and 12, corresponding to materials from pit CEC-01 (depth 4.6–5.0 m) and borehole

SEC-02 (depth 15.6–16.0 m), respectively. The results of the CIU triaxial tests show a dilation even under a confining pressure of 3 kg/cm<sup>2</sup> (300 kPa), suggesting that the silty soil is slightly overconsolidated for the range of confining pressure used. Considering the low hydraulic conductivity of this silty soil, its undrained response and thus use of undrained strength ( $S_u$ ) is appropriate for seismic stability analysis. Measured undrained strengths

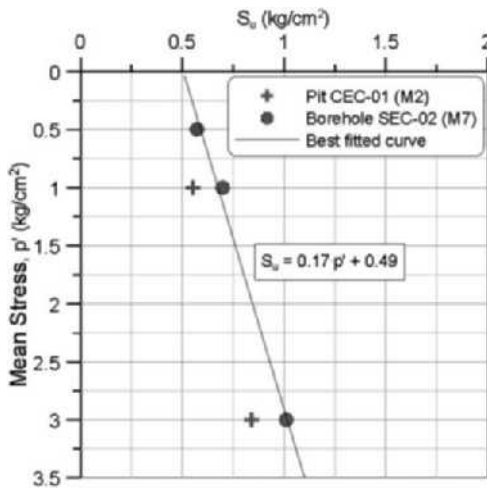
Figure 13. Undrained strength as function of mean initial stress. Coihueco Dam.

are shown in Table 1 and plotted in Figure 13. The geotechnical model adopted for Coihueco Dam based on the available information is shown in Figure 14. The geotechnical properties of these materials used in the model are summarized in Table 2.

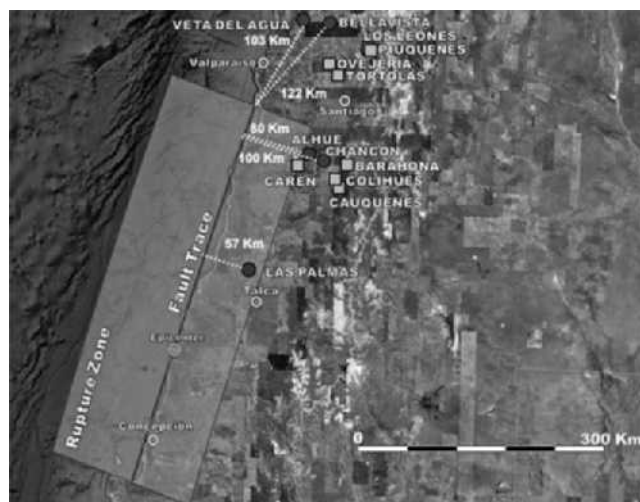
The tailings dams farthest from the epicenter that experienced seismic distress were Veta del Agua Dike No. 5 and Bellavista Dike No. 1. However, the distance of these structures to the fault rupture was only 100 km and 120 km, respectively. The other tailings dams that suffered failures have fault rupture distances of 57 km (Las Palmas Dam), 80 km (Alhué Dam), and 100 km (Chancón Dam). Figure 18 compares these distances to the relationship suggested by Conlin (1987) that relates potential for tailings dam failure to earthquake magnitude and epicentral distance.

**Figure 17.** Large tailings dams with stable response (square) and tailings dams that experienced seismic failures during 2010 Maule Earthquake (circles).

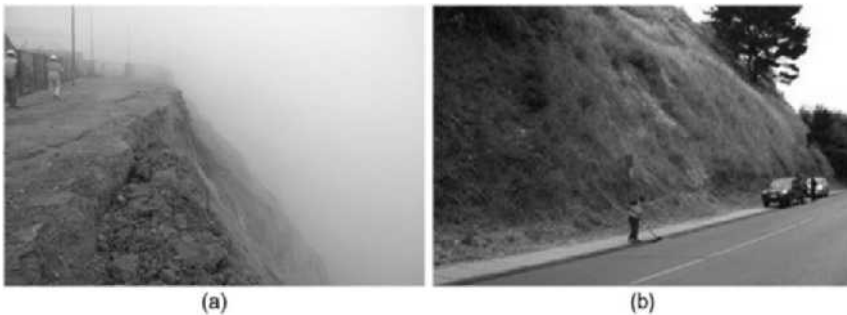
in other areas where no failures were observed. The particular condition that affected the area of Arauco, where these massive seismic slope failures occurred, is the significant tectonic uplift that reached nearly 3 m near the coast. It is hypothesized that the superposition of the inertial forces of the earthquake plus the distortion generated by the crustal deformation could be responsible for the observed slope failures. It is interesting to remark that many steep slopes in other areas such as those shown in Figure 23 did not fail, and only limited surficial displacements were observed.

**Figure 23.** Steep slopes without evidence of major seismic displacements. (a) Near Barahona tailings dam. (b) City of Constitución.

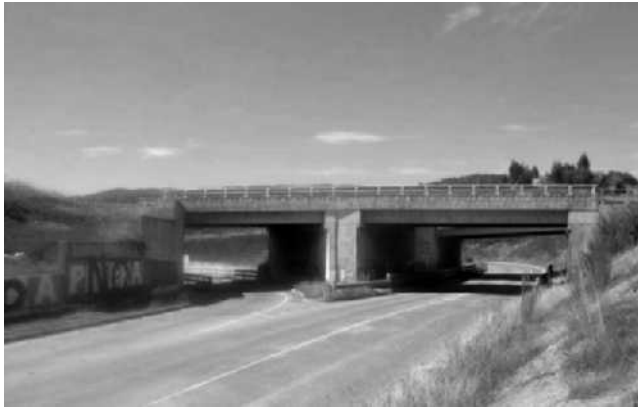
Conventional concrete gravity and cantilever retaining structures similarly performed very well in many different settings. Figure 26 shows an overpass structure on the coastal highway just south of Coronel, about 140 km south of the epicenter in an area that experienced significant shaking. The structure experienced no distress and the bridges were fully functional after the event.

**Figure 26.** Multiple retaining structures for highway overpass structures south of Coronel.
